CHLOE, W. VA.  
NE 1/4 OTTER 15 QUADRANGLE  
N3837.5—W8100.7.5

## LANDSLIDES AND RELATED FEATURES

OF THE CHLOE, W. VA. QUADRANGLE

OPEN FILE MAP 83-80 (F-8)

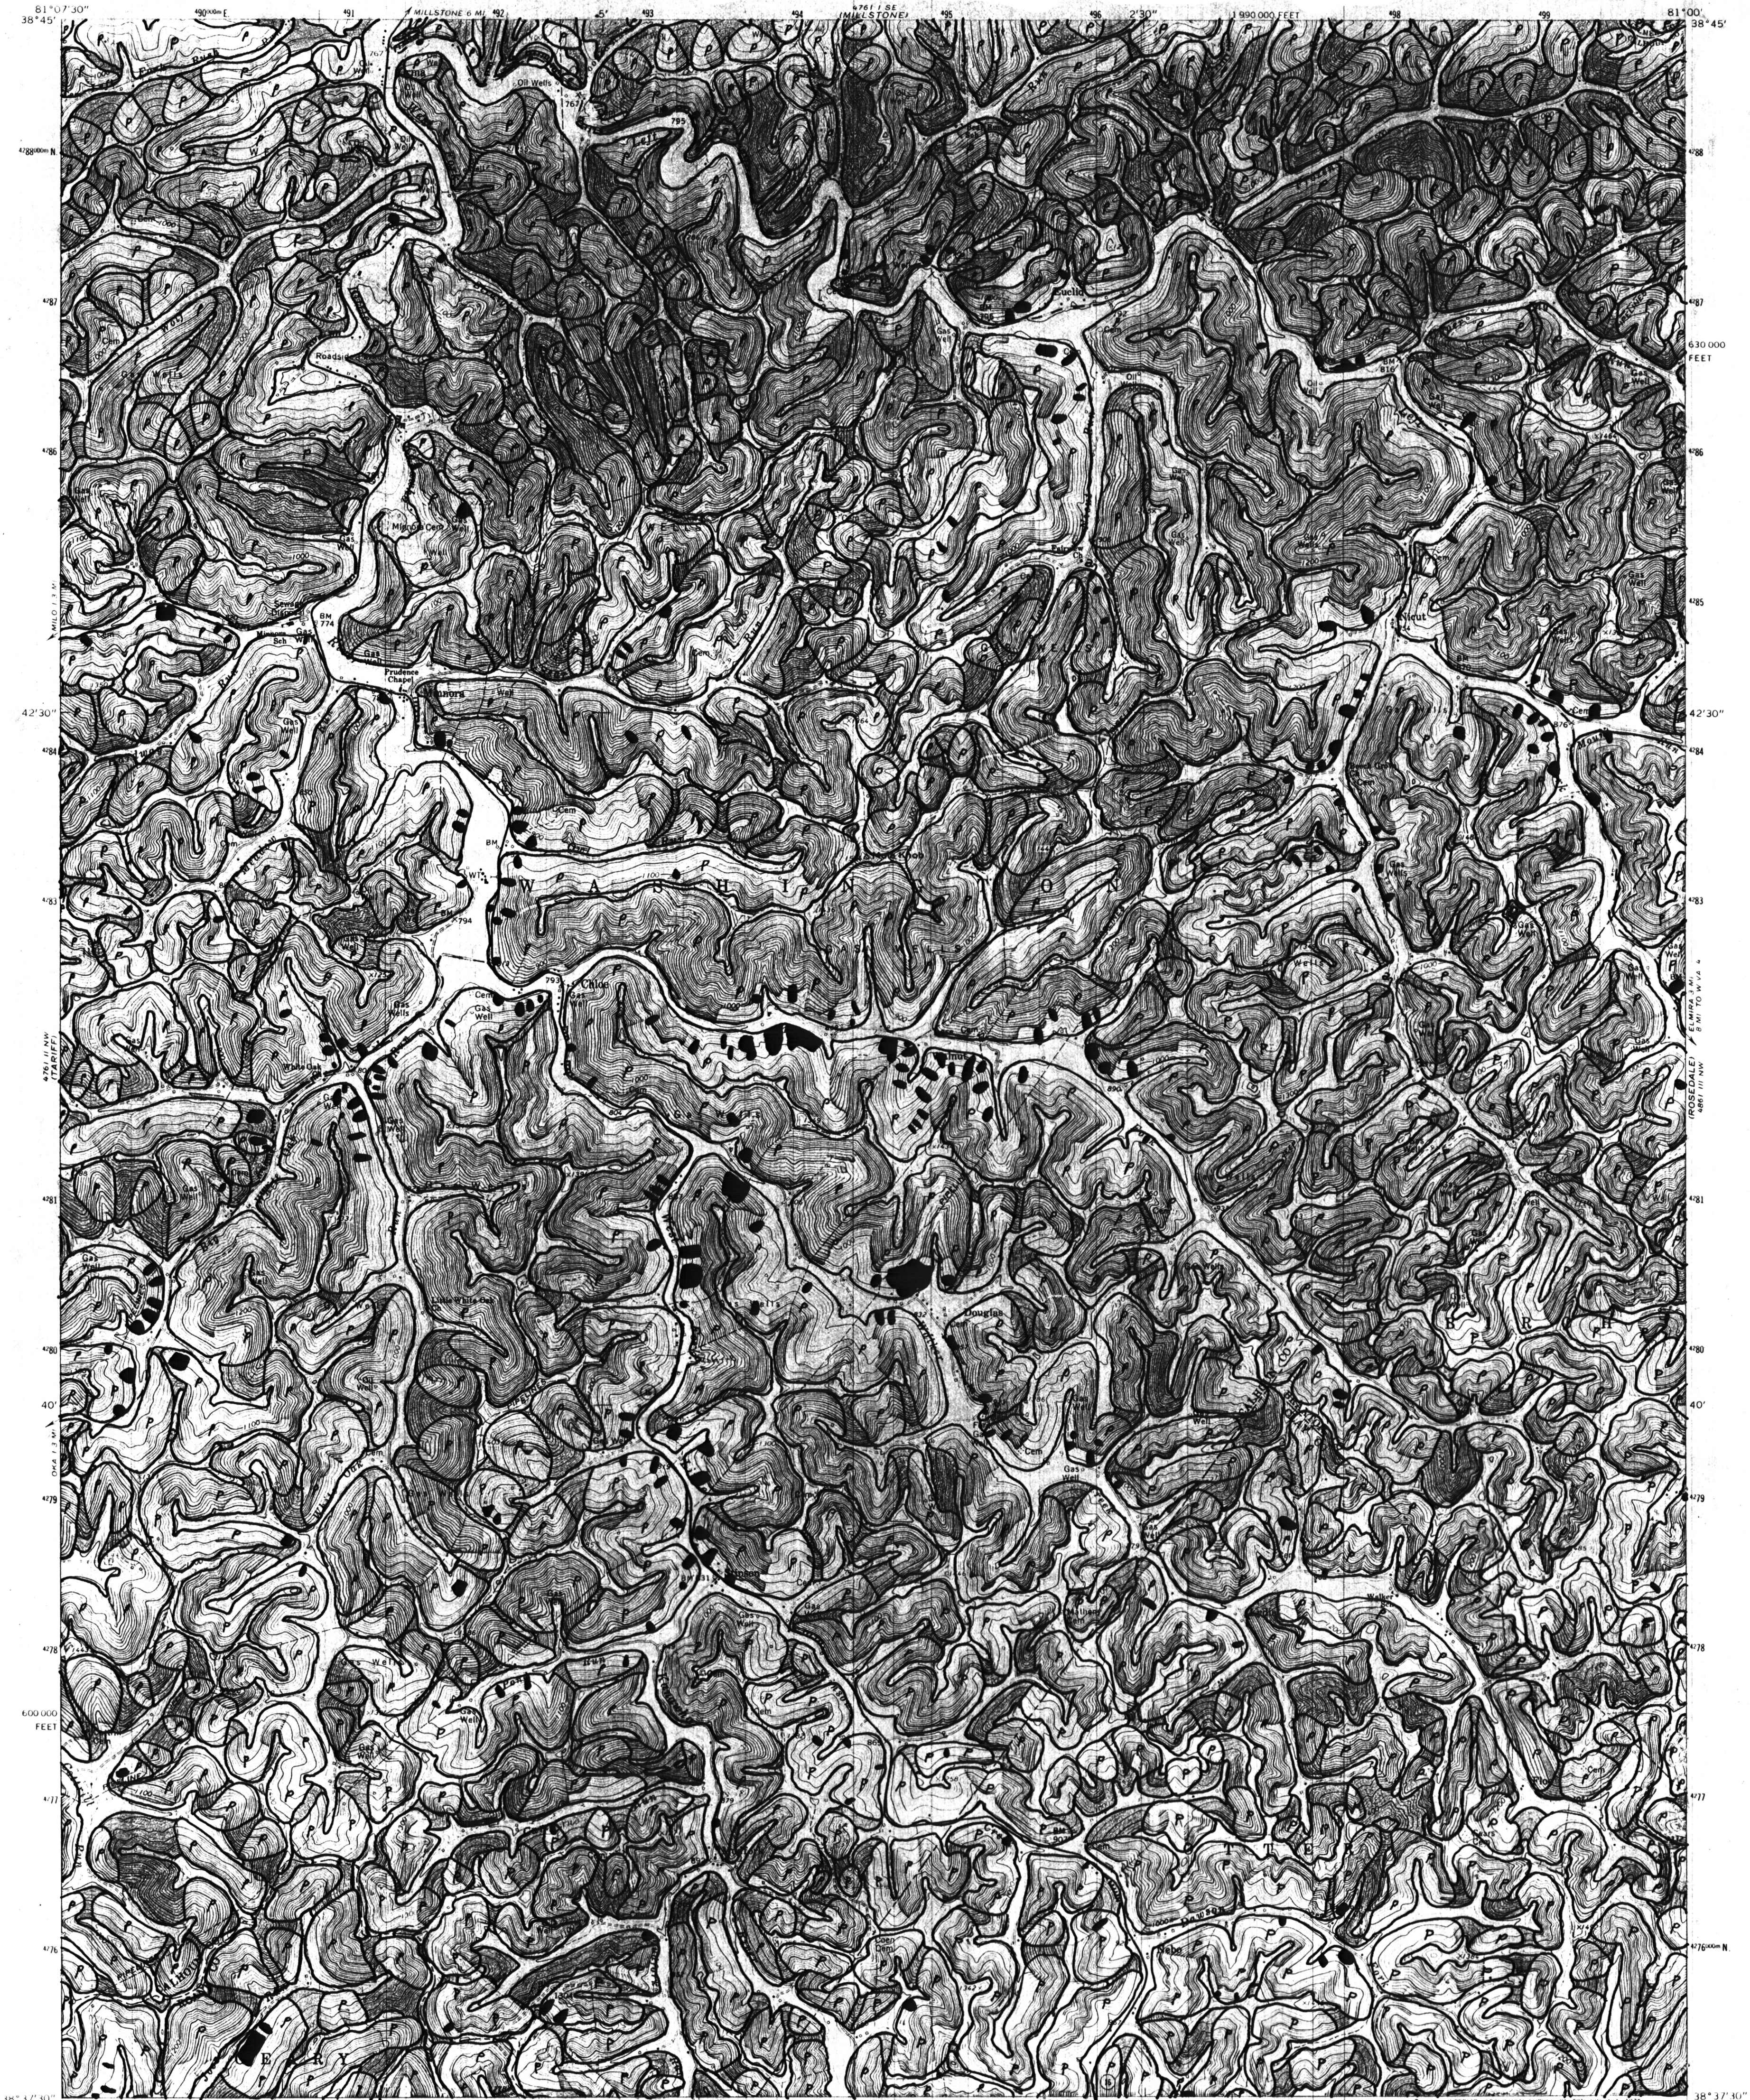
**ACTIVE OR RECENTLY ACTIVE LANDSLIDE**  
Complex landslide composed of earthflow, debris  
slide, earth and rock slump. Identified from  
historical records, and from scars, debris and  
other field evidence. Ground extremely unstable,  
sliding accelerated by excavation, loading and  
changes in drainage conditions. May include  
areas with several active slides too small to  
be shown separately.

**OLD LANDSLIDE**  
Area of extensive hummocky ground caused by  
earthflow and earth and rock slump. Lacks  
clear evidence of active sliding. Relatively  
stable in natural, undisturbed state, generally  
not affected by small structures properly  
sited in areas away from the edge of the toe,  
can be reactivated by extensive, rapid exca-  
vation, loading, and changes in ground water and  
surface water conditions. Area of old landslide  
probably includes recent ones not identified  
from field evidence or otherwise documented.  
Upslope boundary of landslide generally defined  
by modified scarp, but downslope (toe) may be  
gradational and not well defined.

**COLLUVIAL SLOPE**  
Valley wall along major streams with slope as  
steep as 40° (85%), stony, clayey silt soil up  
to 50 ft. (15 m) thick; commonly buttressed by  
a terrace or bench at the toe of the slope, very  
susceptible to sliding by cutting of toe area,  
removal of terrace or bench, and overloading,  
slide commonly activated without apparent cause.

**AREAS SUSCEPTIBLE TO DEBRIS FLOWS AND DEBRIS  
AVALANCHES**  
Primarily shallow, narrow ravines and chutes with  
accumulation of stony colluvium generally 10 ft.  
(3 m) or less in thickness; susceptible to rapid  
movement during intense rainfall. Most ravines  
and chutes designated show evidence of former  
debris flows and avalanches. Symbol 'a' design-  
ates historical debris flow or debris avalanche.

**AREAS SUSCEPTIBLE TO ROCKFALL**  
Steep, locally vertical, natural and man-made  
slopes and cliffs, 15 ft. (4.5 m) or more high,  
formed dominantly of sandstone, limestone, sandy  
shale, mudstone and claystone. Interbedded mud-  
stone, claystone and shale weather rapidly leaving  
sandstone and limestone rock faces unsupported.

**SOIL AND ROCK SUSCEPTIBLE TO LANDSLIDING**  
Soil and rock similar to that involved in land-  
slides elsewhere in map area; primarily areas  
underlain by claystone, mudstone and shale  
associated with other rock types. Rock weathers  
rapidly on exposure forming clayey soil highly  
susceptible to sliding. Includes coves (U-shaped,  
shallow valleys) containing thick layers of clayey  
soil that are very susceptible to sliding where  
excavation breaks continuity of slope and where  
overloaded by artificial fill.

Map areas in which no patterns or symbols are shown;  
primarily valley floors, ridge tops and broad  
benches; modification by excavation and fill may  
lead to local landslides.
